VIMS

Resolution 9 to Demolish Byrd, Brooke, and Davis Halls

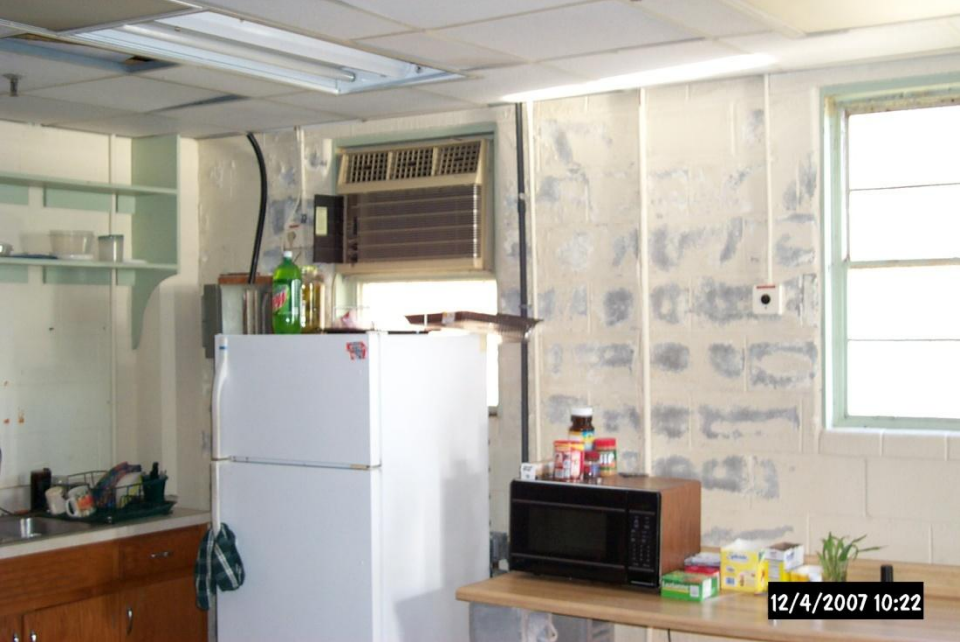
Moisture Bleeding Through Interior Walls

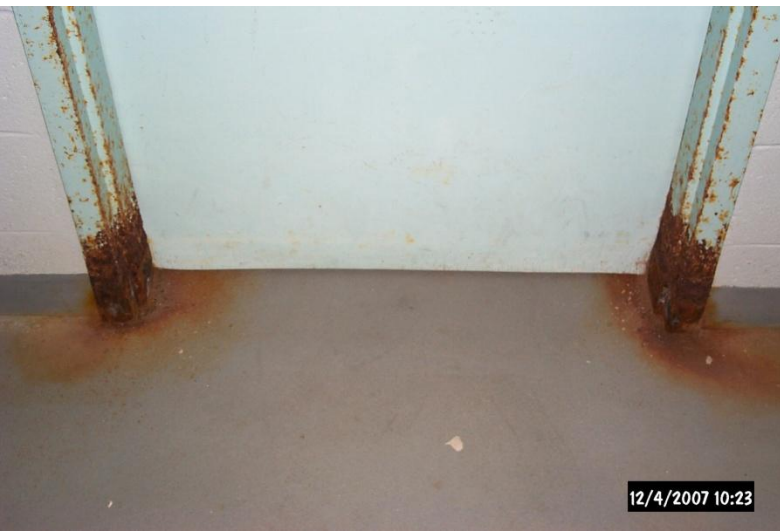
Rusted Door Frame

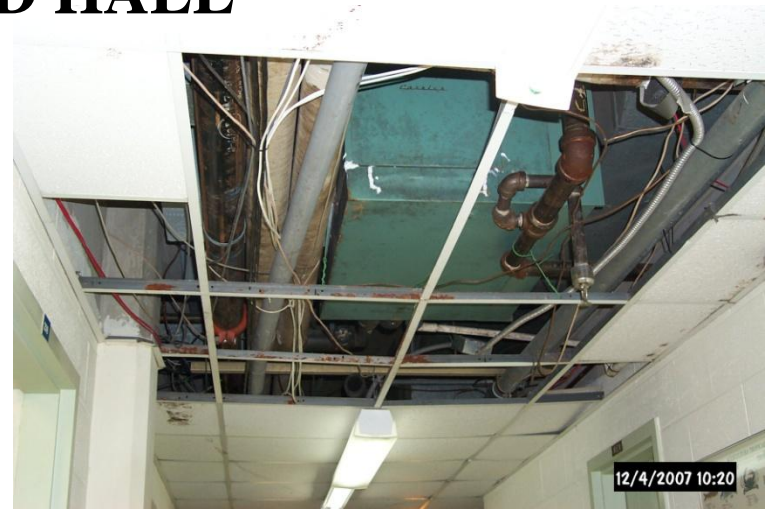
Rusted Mechanical Systems

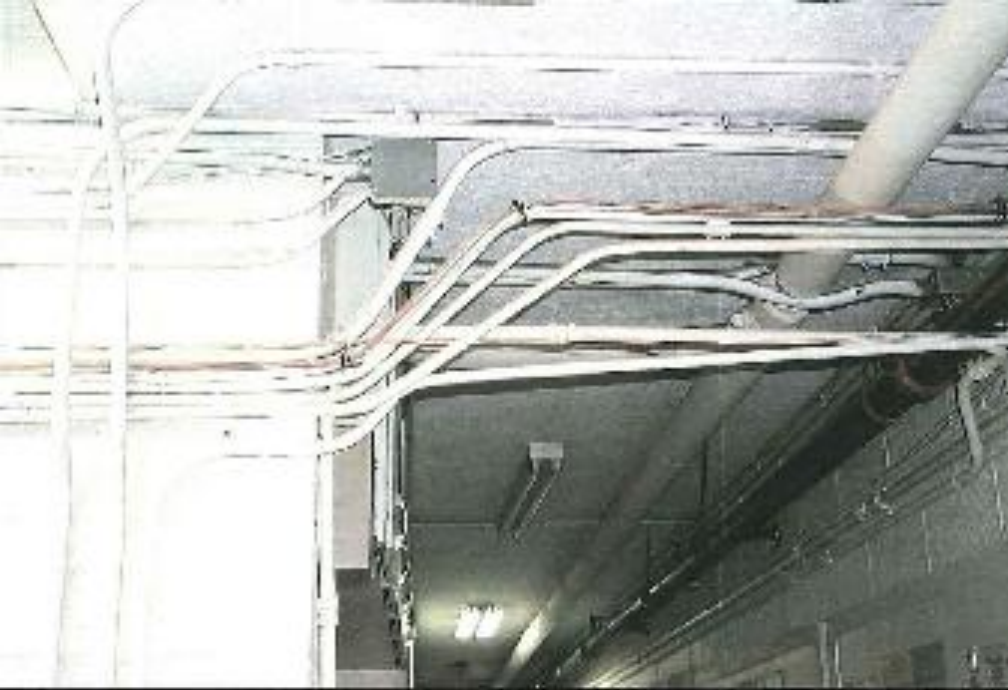
**Exposed Electrical and
Data Wiring**

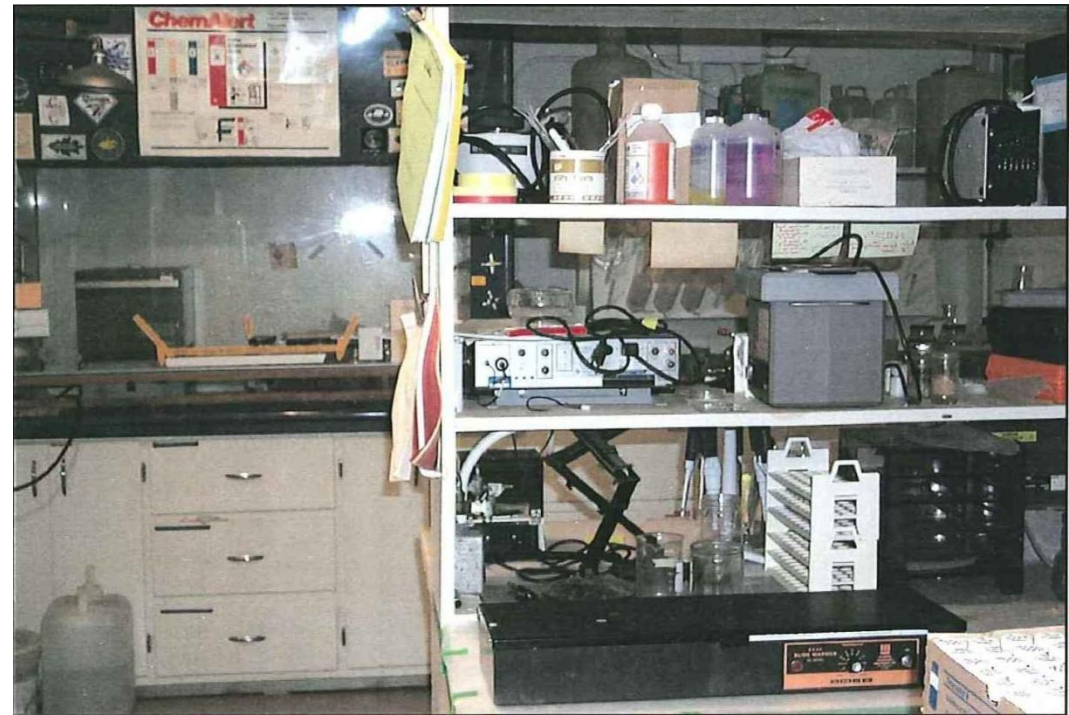
**Crowded Lab
Conditions**

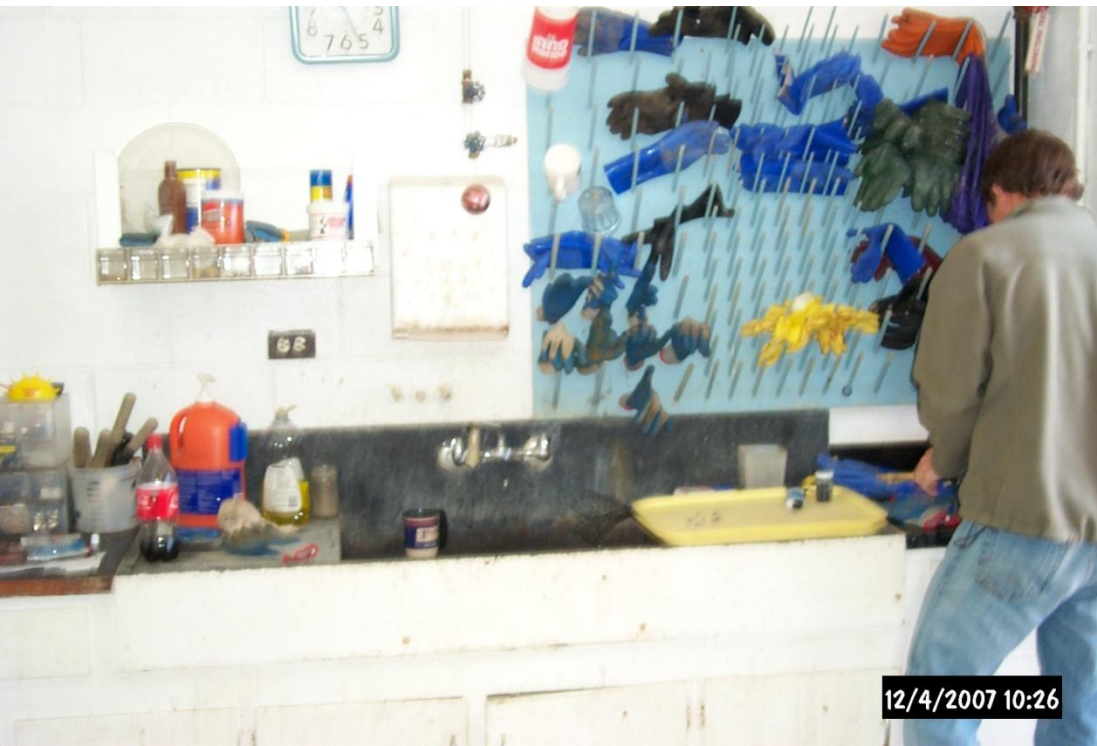
Outdated Labs

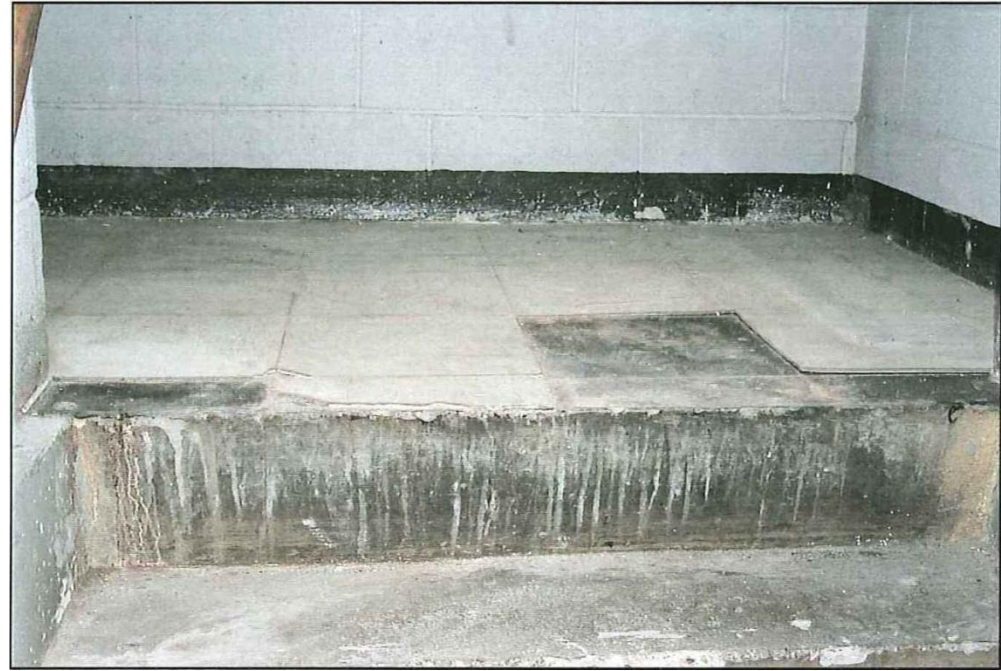
Moisture-Damaged Stairwell
