ARCHAEOLOGICAL INVESTIGATION OF THE PRINCESS ESTATE

ST. EUSTATIUS, NETHERLANDS ANTILLES

AN INTERIM REPORT

Norman F. Barka

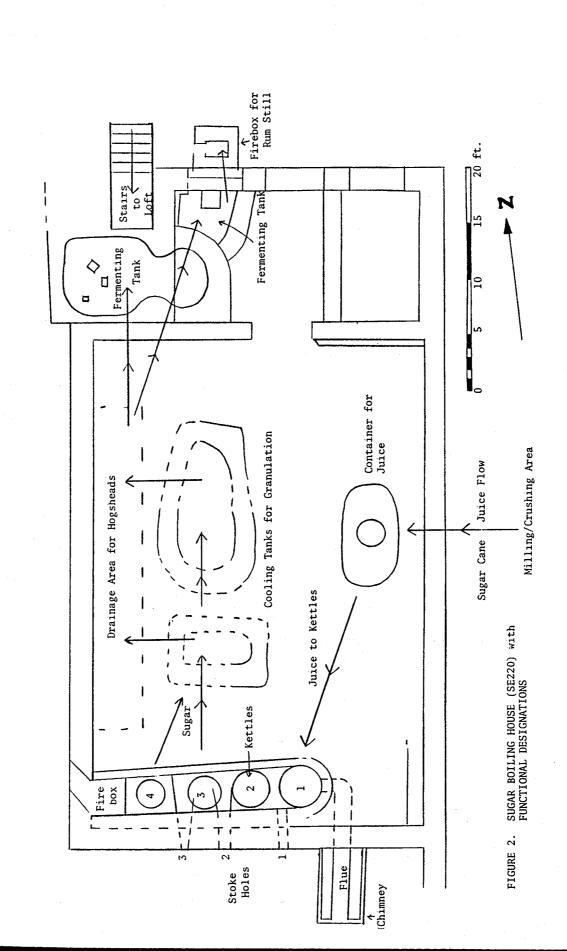
entire building, with arched doorways, had been carefully constructed, as had many sugar houses throughout the West Indies.²¹

The various features of SE220, as outlined in Chapter 1, will now be described as to supposed function. (Figure 2).

Flow Of Sugar in the Building: as depicted in Figure 2, the mill was located to the immediate east of the holding tank (Feature 4). The mill was powered by vertical iron rollers, a few of which were found lying on the ground surface to the east of Feature 1C. (Figure 30).
